HARFORD COUNTY DPW

LOWER BYNUM RUN SMALL WATERSHED ASSESSMENT REPORT

DECEMBER 13, 2019

HARFORD COUNTY DEPARTMENT OF
PUBLIC WORKS

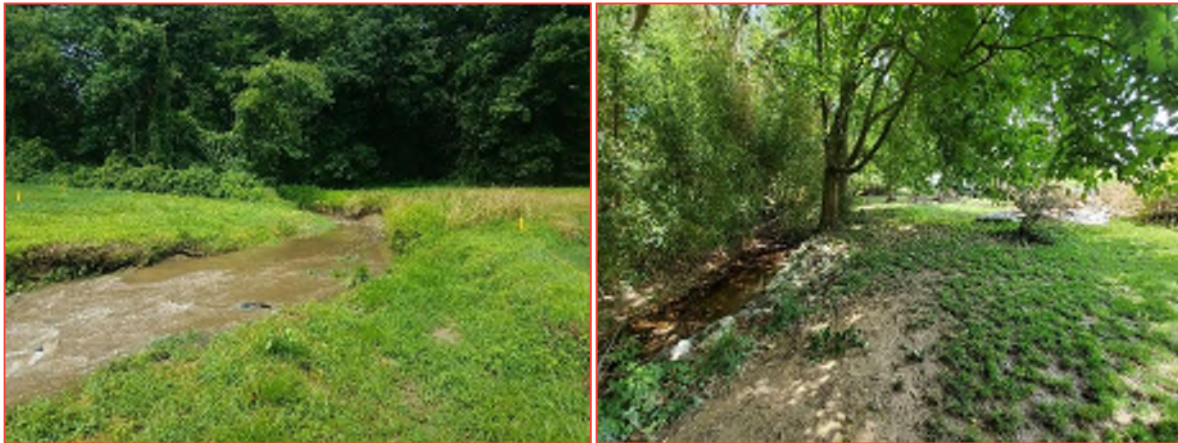
The severity of inadequate stream buffers was rated according to length and width. The most severe rating (very severe) of 1 would be given to inadequate buffer lengths with limited or no trees on either stream bank and no evidence that a tree buffer is beginning to form for a significant length of stream. The existing land use was also taken into consideration, such as pavement, lawn, or shrubs and trees. The highest inadequate buffer rating assigned in the assessed subwatersheds was a severe rating, which was given to three sites. The three sites were in MSB-5 subwatershed. Two of the sites are shown in Figure 4-11. Most sites were rated between moderate (3) and minor (5). Stream buffer restoration potential depends on various factors such as accessibility, property ownership, and current land use. Many of the more severe inadequate buffer sites in the watershed were due to land clearing up to the stream banks in residential yards.

Figure 4-11. Examples of severe (left) and moderate (right) inadequate stream buffers in Lower Bynum Run Watershed

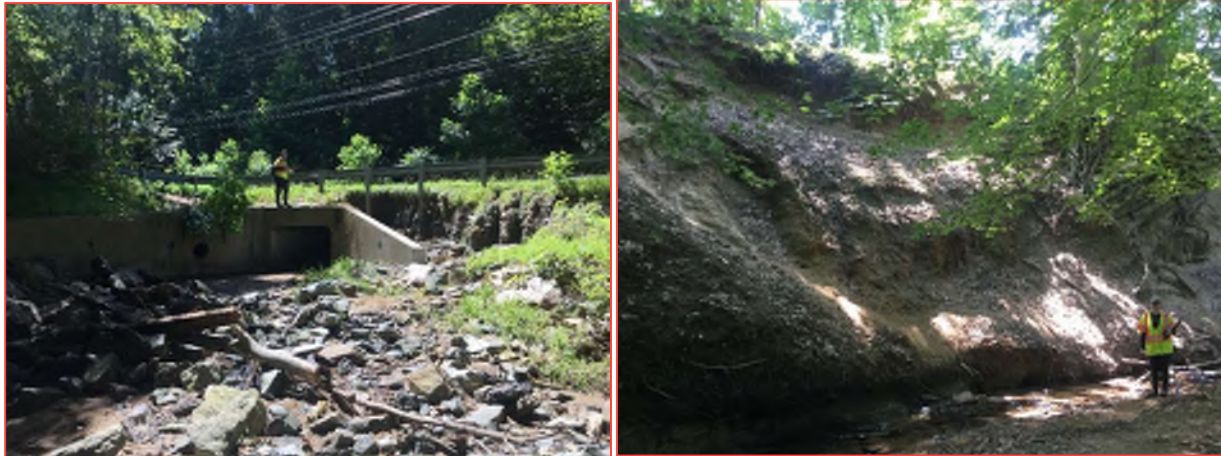
Figure 4-15 shows the two very severe erosion sites. The figure on the left is of site J2-ES-1L, a very severe erosion site with a six-foot average vertical bank height over a 49-foot distance. The section of erosion featured illustrates the threat to the outfall structure and adjacent roadway. The erosion site has been classified as Stage I – Incision. The figure on the right is of site R3-ES-3L, a very severe erosion site in MSB-5 with 15-foot vertical bank heights over a 146-foot distance. The erosion at this site is currently threatening an outfall structure downstream of the bend pictured. The erosion site has been classified as Stage II – Widening. The location of all erosion sites can be seen in Figure 4-16 through Figure 4-18.

Figure 4-15. Example of a Very Severe Erosion Site in MSB-4 (left) and a Very Severe Erosion Site in MSB-5 (right)

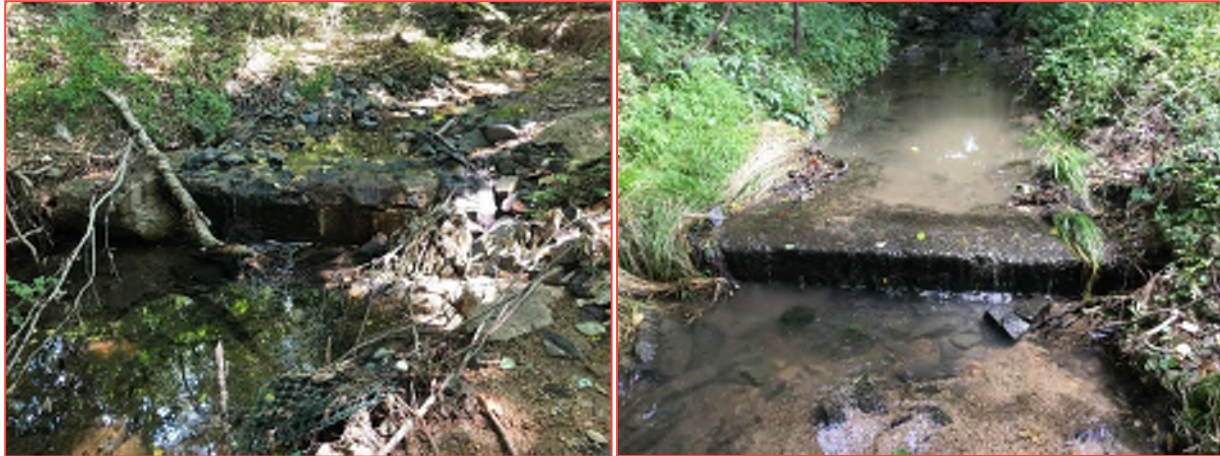
Figure 4-19 shows two low severity fish barriers where the drop between the respective pipe crossing or concrete weir and the natural channel is too high for the fish to pass and/or too shallow. In all cases, the location of the fish barrier within the subwatershed has an impact on the severity rating.

Figure 4-19. Example of a low severity fish barrier created by a pipe crossing (left) and a low severity fish barrier created by a concrete weir (right)

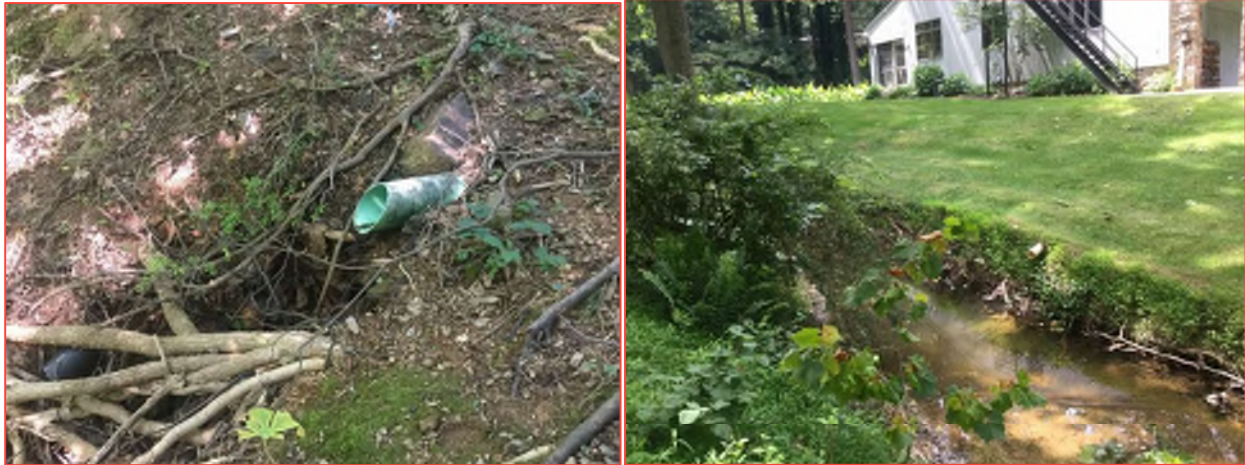
Figure 4-20. Example of a moderate pipe outfall (Left) and a minor underdrain pipe outfall (right)

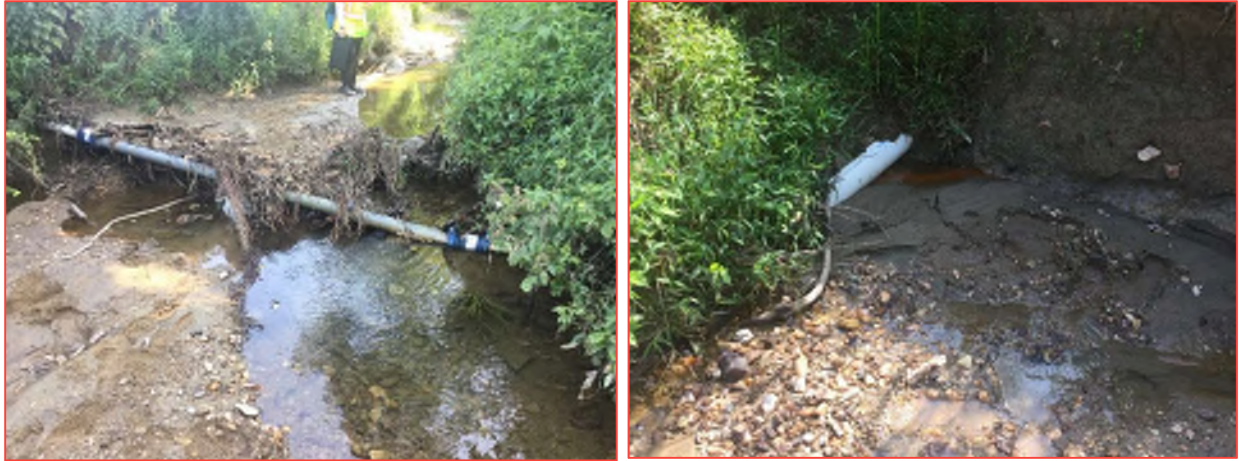
Exposed pipes were also assessed and include any pipes that are in the stream or along the stream's immediate banks that could be damaged by a high flow event. These pipes are usually utilities other than stormwater, such as electrical, sewer, etc. Exposed pipes include manhole stacks and pipes exposed along the stream banks or under the stream bed. These pipes can be vulnerable to puncture by debris in the stream and pose a threat to water quality depending on the contents within the pipe.

Figure 4-21: Moderate exposed pipe (left) and discharging exposed pipe (right) in the MSB-5 subwatershed

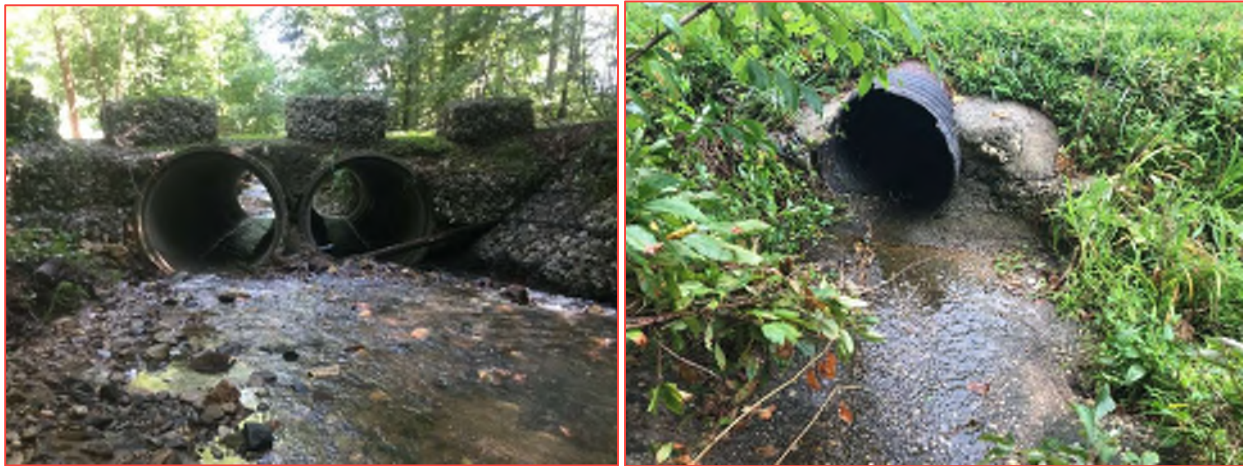
pictured in Figure 4-22 (left). A common type of channel alteration observed throughout the Lower Bynum Run watershed was upstream and downstream armoring of channels and banks for road-crossing stabilization (Figure 4-22, right).

Figure 4-22. Examples of two severe channel alterations to convey flow under a roadway (left) or by hardening the channel with concrete (right)

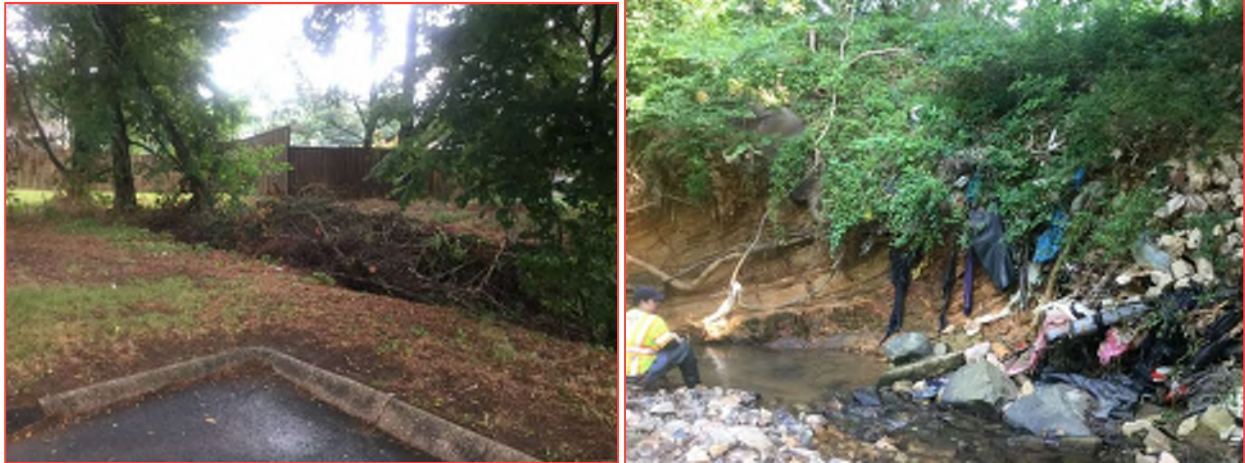
A total of 3 trash dumping sites were documented during the survey for the stream lengths surveyed. A moderate trash dumping was the highest ranking for the Lower Bynum Run watershed. The remaining sites inventoried for trash dumping were ranked minor. Both examples in Figure 4-23 are accessible and could be cleared by volunteers within a few days.

Figure 4-23. The moderate trash dumping site found within the MSB-4 subwatershed (left) and a low severity trash dumping within the MSB-5 subwatershed (right).
